**Survey Report of the 'part' foremast of the wreck of the Steam Trawler
Sheraton, lying in the inter-tidal zone off Hunstanton, North Norfolk**

Submitted as part of the NAS Part II intermediate certificate in Foreshore and Underwater
Archaeology

Jezz Davies

March 2010

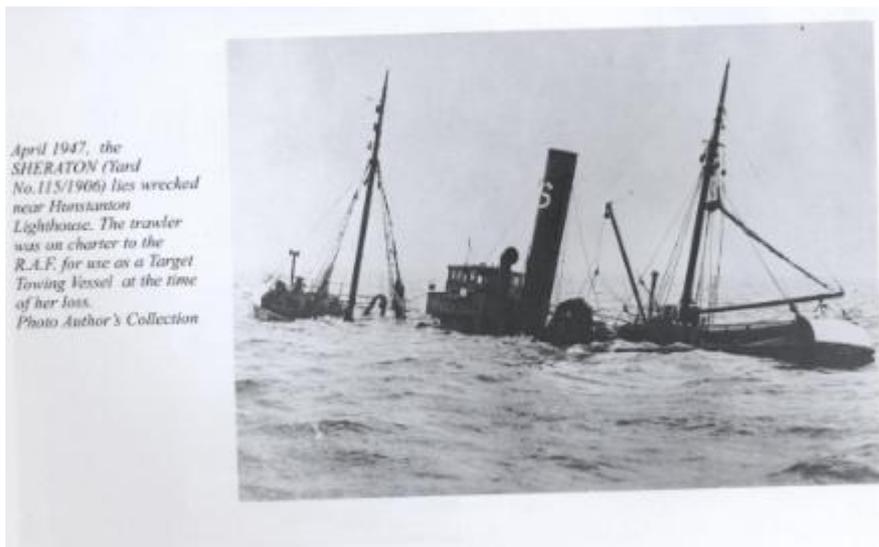
Figure 2: The Sheraton grounded at Hunstanton (from Cook, Welton & Gemmell. Hutton Press 1999)

Two of the photographs in this report show The Sheraton grounded at Hunstanton. However, the pictures at Figure 2 and Annex E do not appear to be the same vessel. The vessel at Figure 2 has 2 masts. The vessel at Annex E has only one mast and is fitted with large radar deflectors, intended for use in the target practice exercises.

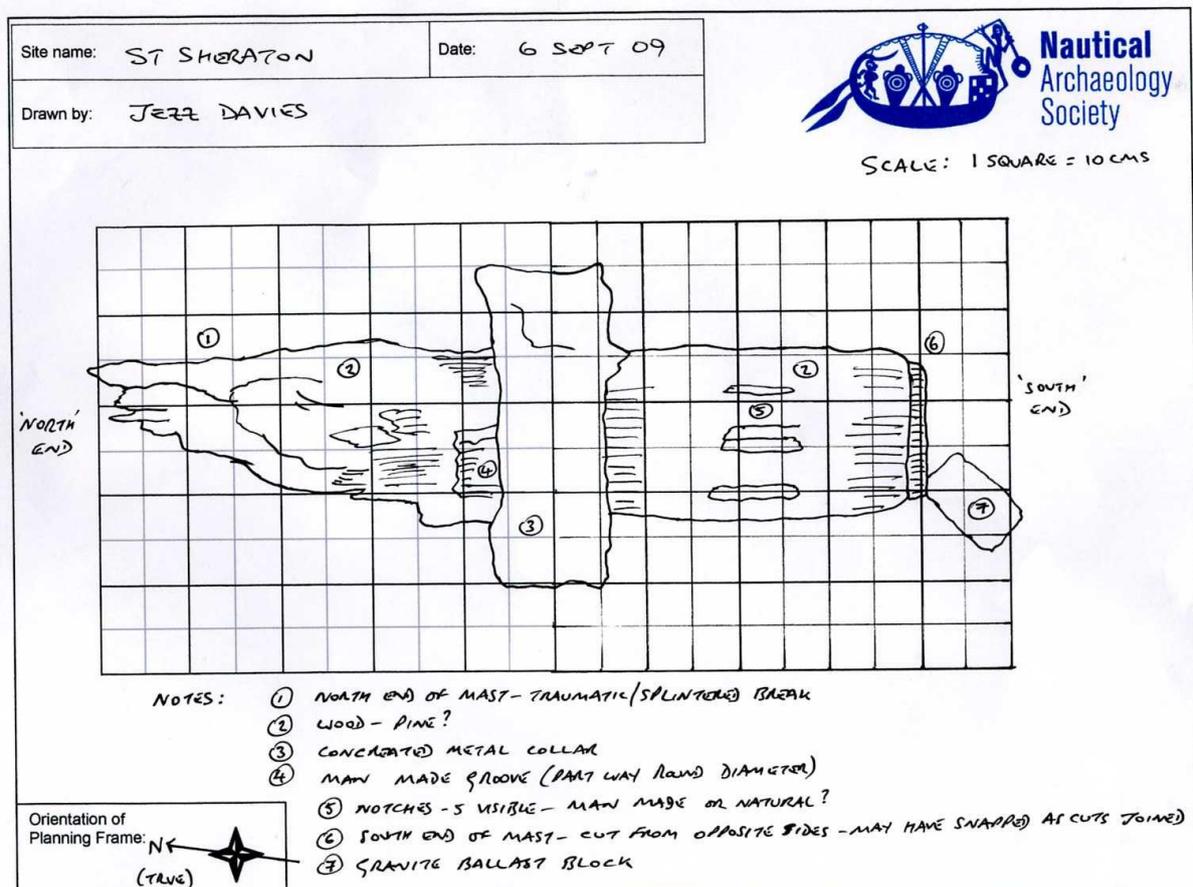
Figure 3: Planning frame sketch of The Sheraton foremast

The planning frame sketch results are shown at Figure 3. The foremast is almost lying in an N-S orientation, the fragmented end pointing towards 350°. For the purpose of this report, the fragmented end of the foremast will be referred to as the 'northern' end and the cut or straight end as the 'southern' end.

The wooden section of mast uncovered measures approximately 1.85m long and is a maximum of 0.35m diameter. The metal collar currently measures approximately 0.70m diameter and a depth (or vertical height) of 0.27m. The original dimensions of the metal are hard to establish due to the concretions.

The southern end of the mast appears to have been sawn through from opposite sides but not quite at the same height; there is evidence that the mast may have snapped as the 2 cuts approached each other. There is also evidence of grooves (5 visible; there may be more still in the buried section), probably man made, though weathering is also a possible but less likely option. The grooves are not evenly spaced.

The northern end of the mast appears to have met a catastrophic failure with evidence that the wood has fractured starting at a point some 0.2m from the collar. There is evidence of a man made groove directly adjacent to the collar, approximately 0.25m in length and 0.1m depth.

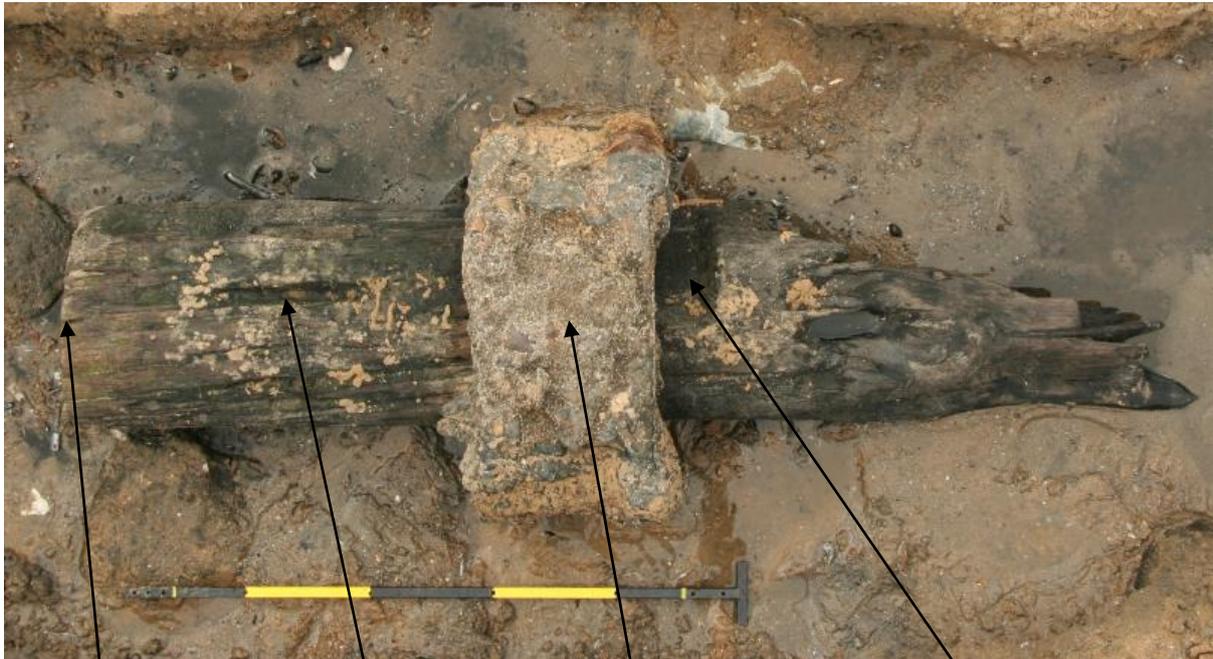
Sheraton and Viola mast comparisons

- The Viola mast dimension of 0.35m diameter, equate exactly to that of The Sheraton.
- The presence of securing wedges could well explain the grooves on The Sheraton mast on one side of the collar.
- The wide groove on one side of The Sheraton mast would seem to relate to the location of the metal that joins the 2 collars on The Viola.

Mast cut here?

Site of wedges?

Metal collar?

Part of bracket fitted here?
