Cambridge Archaeology Field Group

Field walking and field drain finds

A discussion of their history and
typical finds from field walking

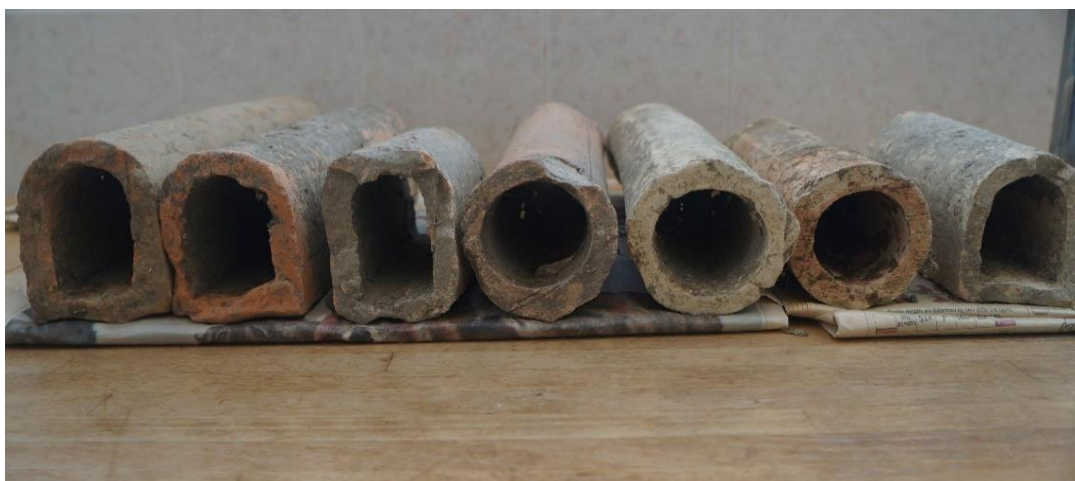
Figure1. A selection of field drains from an excavation at Lamp Hill, Wimpole (Photograph courtesy of Mike Coles).

A category of finds that we do not keep, but are common on the clay lands of Cambridgeshire, would be parts of field drains, like those shown in Figure 1.. These ceramic pipes, when broken, may often be confused with being domestic pottery. In addition there seem to be no publications that discuss these finds and their dating. So is it possible to date these finds? Firstly, then, we need to understand some of the history of field drains and their use.

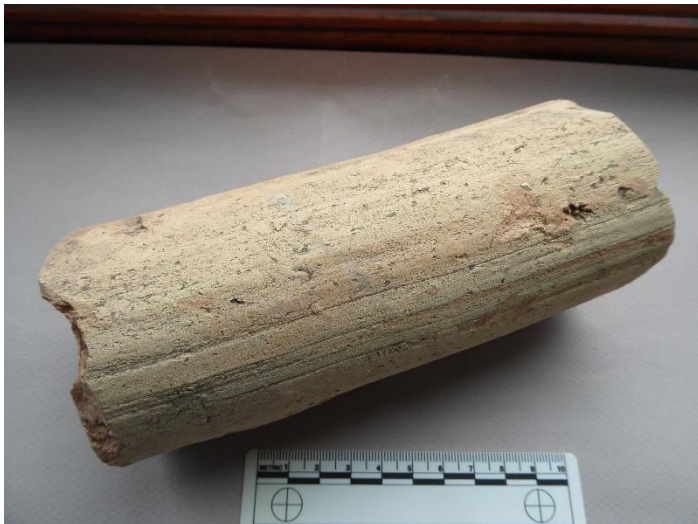
Figure 4. Section of ceramic drain pipe with extrusion lines visible (Authors photograph).

The drains we find are normally broken fragments so that it is usually impossible to say what the exact design was, although extrusion marks are usually quite obvious as seen in Figure 4.

This photograph shows a section of modern circular ceramic drain with the longitudinal extrusion marks clearly visible.

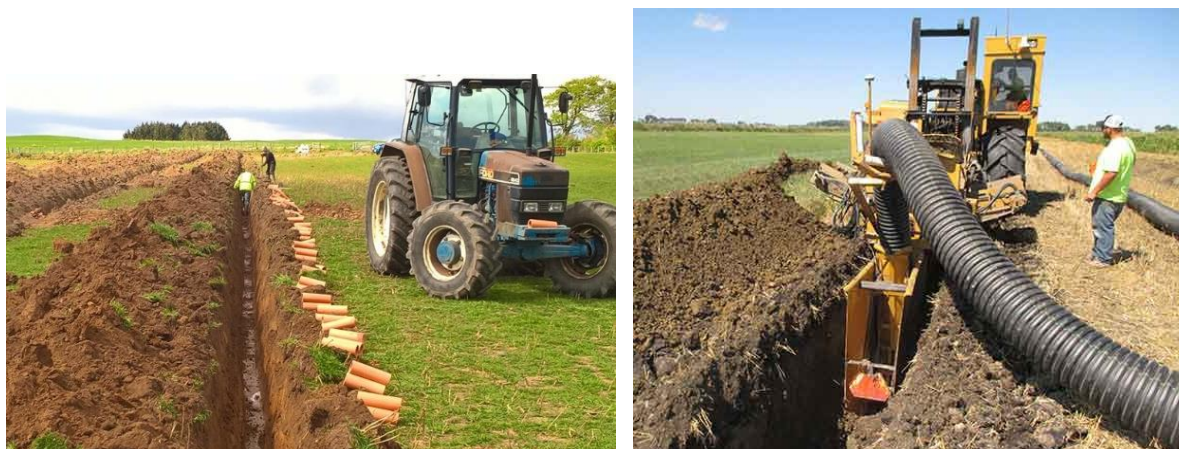
Figure 5. Modern drain installation (Knowlesdrainage.co.uk)

Some contractors still instal ceramic drains manually in excavated trenches, as shown in the left hand photograph in Figure 5 below.

However, the most likely form of drainage today will be plastic pipe of varying diameters laid mechanically as shown in right hand photograph in Figure 5 above. However, with the effects of climate change forecast to increase the amount of rain falling, scenes like the one below may become more common as more drainage is required to keep field flooding under control.

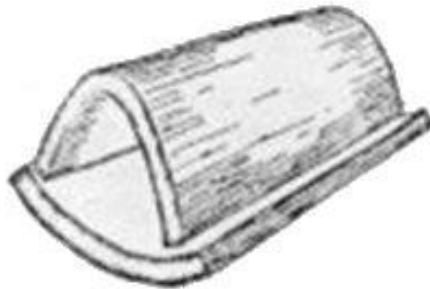
An example of a horse-shoe tile on a flat base. Length 12". Overall height 3.5", 5.5" overall width and slab thickness is 0.65". The base is 6.5" wide and 0.75" thick. From Nottingham.
